11 kV Feeder - Source Of Tripping Detected

Paul Douglas from Line Scan Services (New Zealand) pinpoints with the DayCor camera the source of tripping of a 11 kV feeder

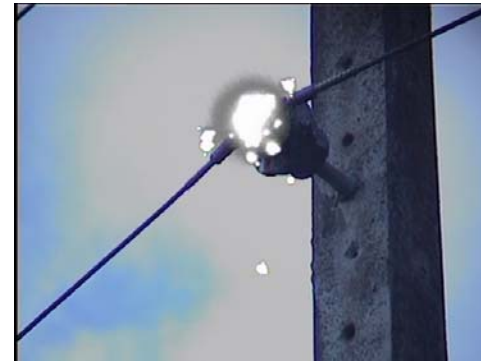
One of the line supervisors was aware of me trailing the DayCor corona camera out for detection of these particular types of intermittent faults and notified me. I looked at the A.B. Switch and found nothing abnormal; the next pole along showed excessive corona discharge from a bridging insulator, which I thought, could be the fault. The line tripped another three times over the weekend until it was reported by local residents of sparks coming from a pole. I then had another look with the camera and captured the images of the insulator before being replaced and afterwards. The insulator had a small pinhole in the top where it had been leaking to ground through the pin and concrete pole.

Figure 1: Insulator on 11 kV line with excessive corona

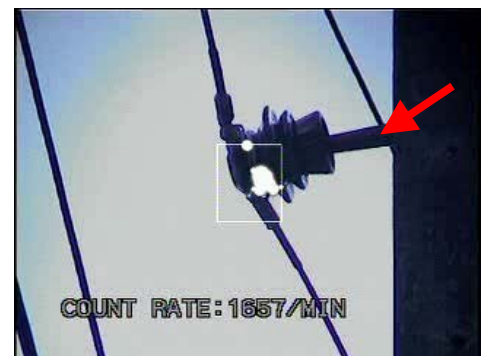
This section of line is the only part of this particular feeder that is constructed in this manner and is approx 30 years old; all other insulators are mounted on x-arms. The first insulator I discovered was also looked at and was found to have a small chip on the second or largest skirt.

Figure 2: Insulator on 11 kV line with excessive corona

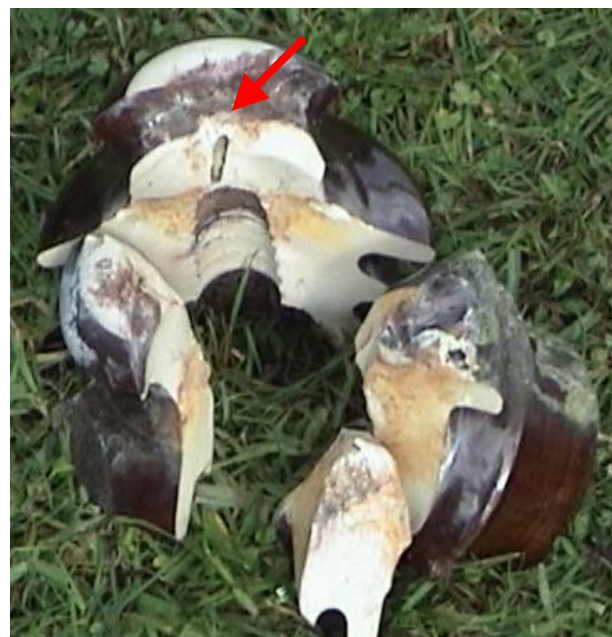
Figure 3: Insulator dissected to show pinhole.
