Whilst carrying out a helicopter overhead power line inspection for a local distribution network operator, (DNO) we found a broken strand on one of the tension tower droppers (275kv)

Helicopter overhead power line patrol using the DayCor II corona camera

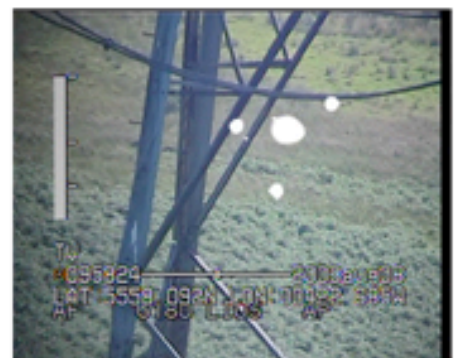
Broken conductor strand on 275kv dropper

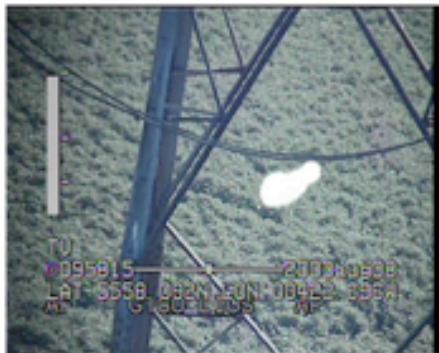
This was visible from over a span away using the corona camera but would have been easily missed on a normal visual patrol.

As you can see from the pictures included the discharge is coming from two main areas, one is the longer strand on the left, and one is the shorter one on the right (see close up)

Corona discharge visible from broken conductor strand

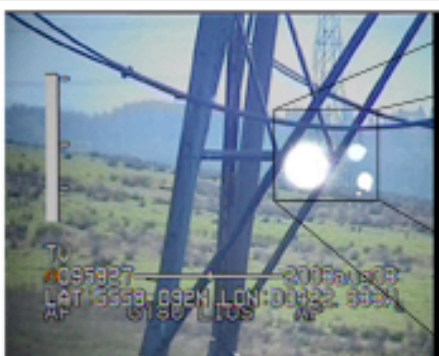
One of the strands now visible to the naked eye

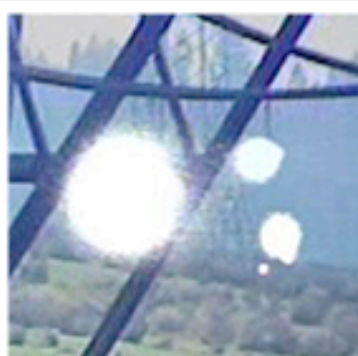
Close up of broken strand
