Real Life  
Case Study

# RADIO INTERFERENCE

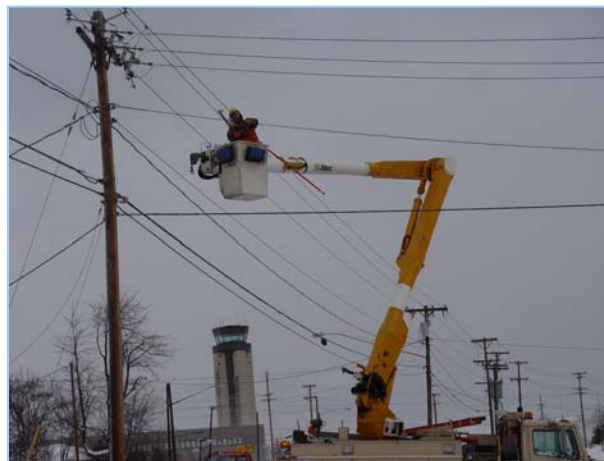
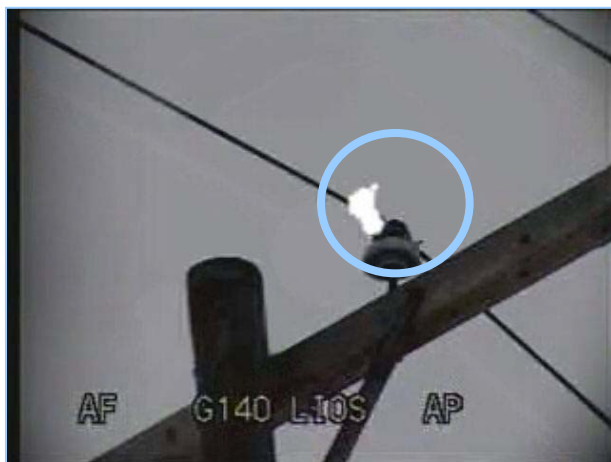
Corona due to a loose tie wire that disturbed radio communication of the control tower of an airport, was immediately located by the DayCor camera.

Line crew replaced **only** the hardware that was found to be defective using the DayCor II Corona Camera.

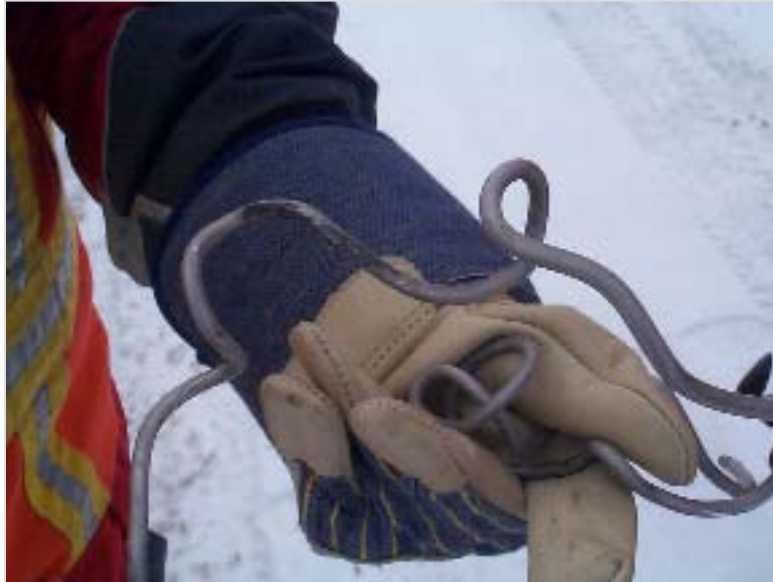
Flat spots on the aluminum tie wrap were found on on the 12.47 kV pin insulator .

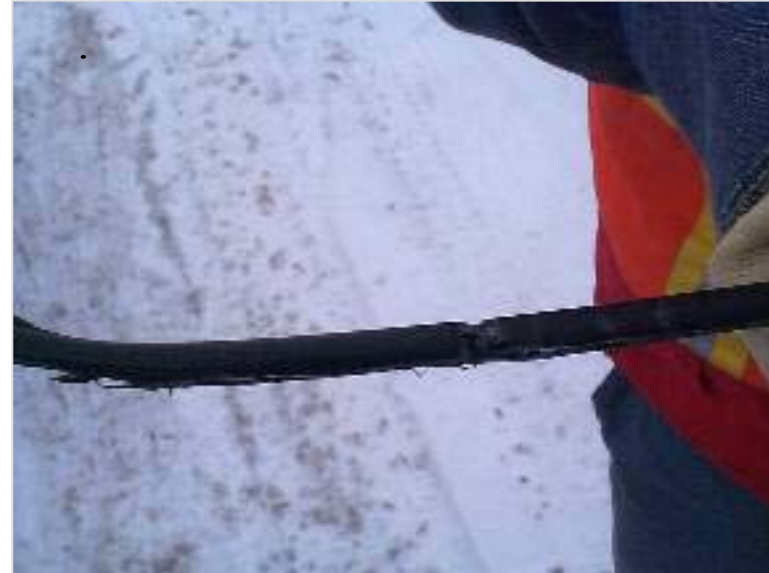
The rubber-covering on the 12.47kV wire: erosion of the rubber was caused by arcing on the 12.47kV wire that was attached to the pin insulator.
