Corona Camera with Documentation package

Detection of high voltage leakage between phases on large AC generator (1000 Mega Watt) stator using the DayCor®II

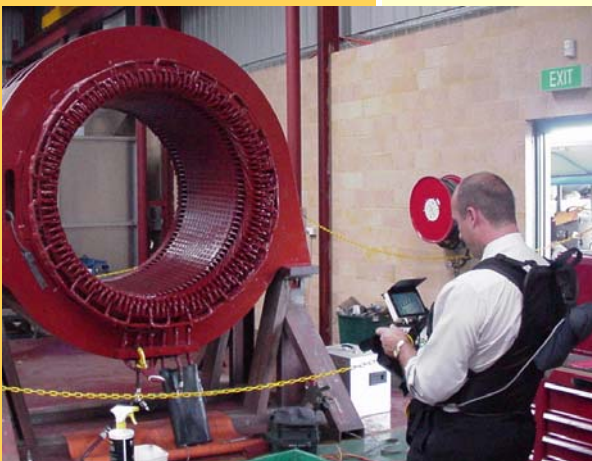
With the start of the test and increasing the test voltage on one of the phases to some 38 kV, weak corona was seen on a part of the winding at a different location on the stator compared to the first finding. As the voltage was increased severe corona and arcing and eventually smoke indicated insulation fault. The location of the fault area was marked for investigation. The affected part of the insulation was removed and revealed contamination in this part of the winding.

As new Hi-Pot tests were performed, voltage was increased to over 44 kV with no corona or arcing present. Re-insulation of the affected areas took place and the generator was assembled.
