29/09/2003

Eurotunnel Electrical Train Line inspection with the DayCor®II camera

by **Controle et Maintenance (C&M) -
France**

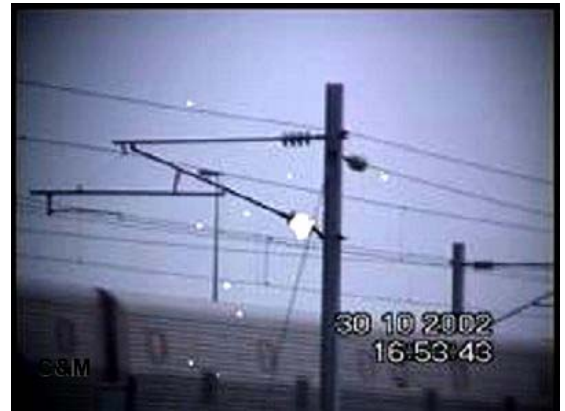
Figure 1: Note the strong discharge on the lower insulator of the pylon on the right side of the railway

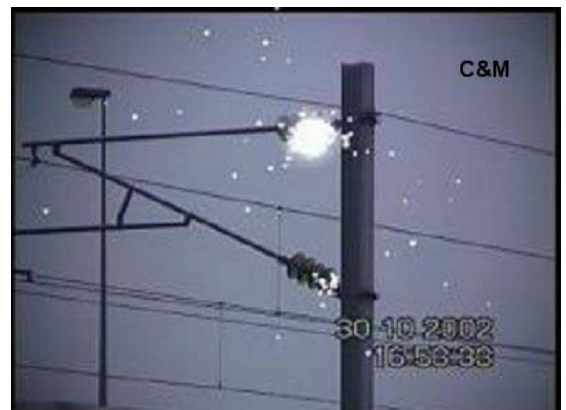
Figure 2: Pylon on the right side of railway. There is Corona on the lower insulator and arcing on the upper insulator. This side was not washed

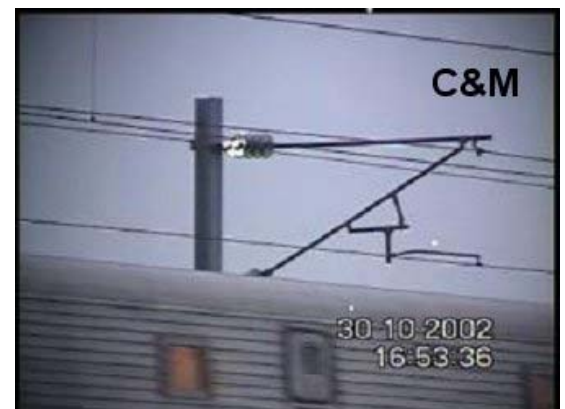
Figure 3: Corona on one of the insulators on the left side of the railway. This side was washed, the discharge on this insulator is due to either insufficient washing or the team skipped this insulator for unknown reason
