## Case Study:

# Contamination

**Areva**, a power generating company in New Zealand, ordered inspection services from:

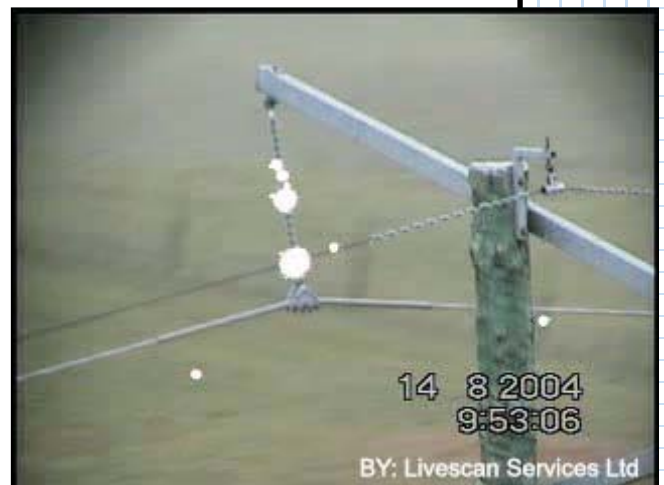
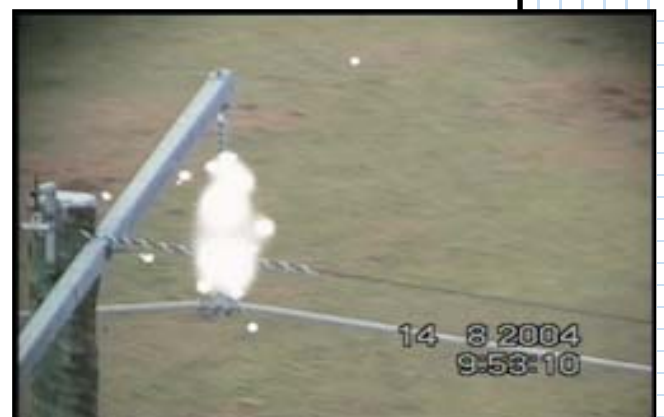
"...I flew the line with the camera and found intense corona on the line at some pole locations and on the particular phase that was indicating the transient fault.

These were replaced with new insulation and corona rings, and the faults stopped. The whole line had varying amounts of corona activity on the insulation. Analysis of the insulation indicated contamination of geothermal origin (geothermal discharges of steam etc... to the atmosphere) and a reduced creepage distance on these items under moist conditions.

Airborne inspection: Strong discharge observed with the DayCor camera.

UV gain is 110 on a scale of 250

Design engineers are now looking for a suitable replacement for the insulation on this line in the designated places. It was decided that I will do a yearly condition inspection on the remaining lines."
