Detection of Potential Failure Using the DayCor II Corona Detection Camera

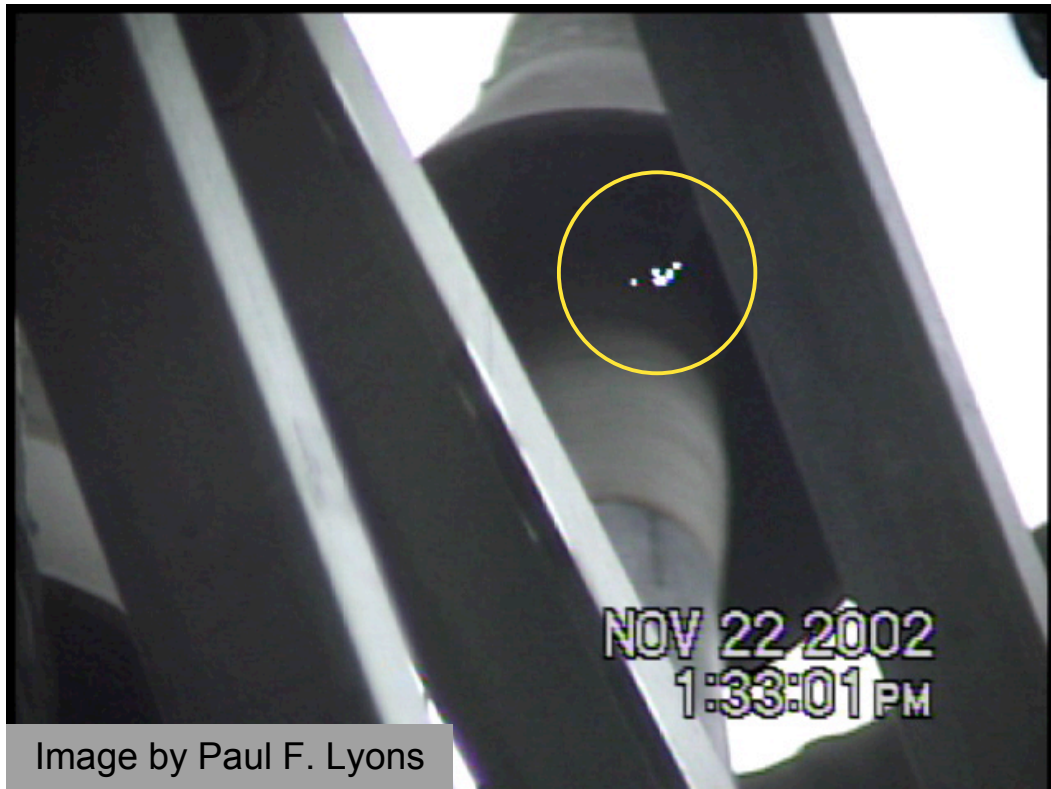
The image above is of a cable transition from overhead to underground. The voltage is 12.8 kV. This type facility exists at distribution and transmission voltages, wherever a transition from an overhead line to an underground cable is required. The presence of corona in the image indicates that a potential insulation failure is very likely to occur on this phase.

A defect in the transition could be the result of damage to the transition or improper installation. In either case the higher than normal voltage gradient in the cable transition is causing the corona in this image.
