We are pleased to provide the following NEW APPLICATION NOTE, once again showing the versatility of the DayCor® Camera and the cost savings from its use. 6/2006

The Solarblind DayCor® II helps solve a nasty RFI (Radio Frequency Interference) problem.

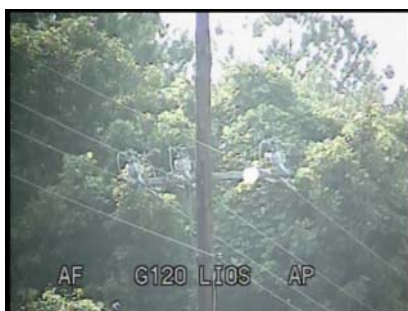
When using the DayCor® camera and looking at the problem pole no indication of corona or arcing was seen. Pointing the DayCor® camera to the two poles on the left side did not show anything. When aiming the camera to the right to view the other two poles, **a severe corona indication was detected on the second utility pole.**

Arcing corona seen hundreds of feet away on hazy day.

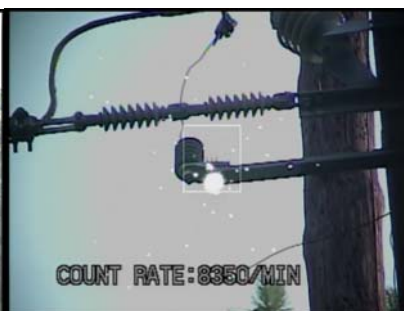
Moving the DayCor® camera to this location for a closer look, arcing was detected at the bottom of a lightning arrester. **The arcing strength was measured with the DayCor® Corona Camera counter and was found have a count rate of 8,000 to 10,000, extremely high!** The location of the arc was between the bottom of the lightning arrester and the support bar. The lightning had shorted out the lightning arrester and burnt out the grounding wire.

The exact corona arcing location

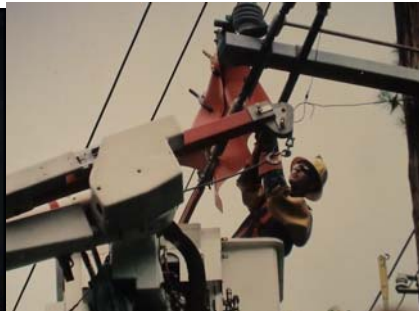
Lineman from EMC takes down the faulty arrester

The local EMC called in one of their bucket trucks and the faulty lightning arrester was disconnected and brought down for evaluation. It had zero Ohm resistance and was discarded. **The Radio Amateur Operator reported that all the radio interference was now gone and the noise level was measured to be below S1.**

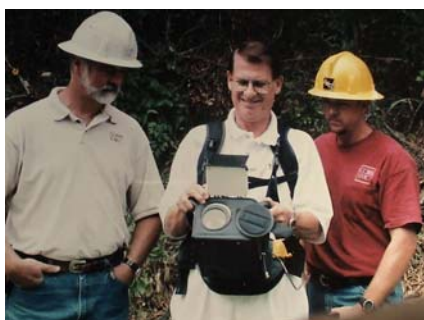
EMC crew studies the corona camera image
