Real Life  
Case Study

# RADIO INTERFERENCE

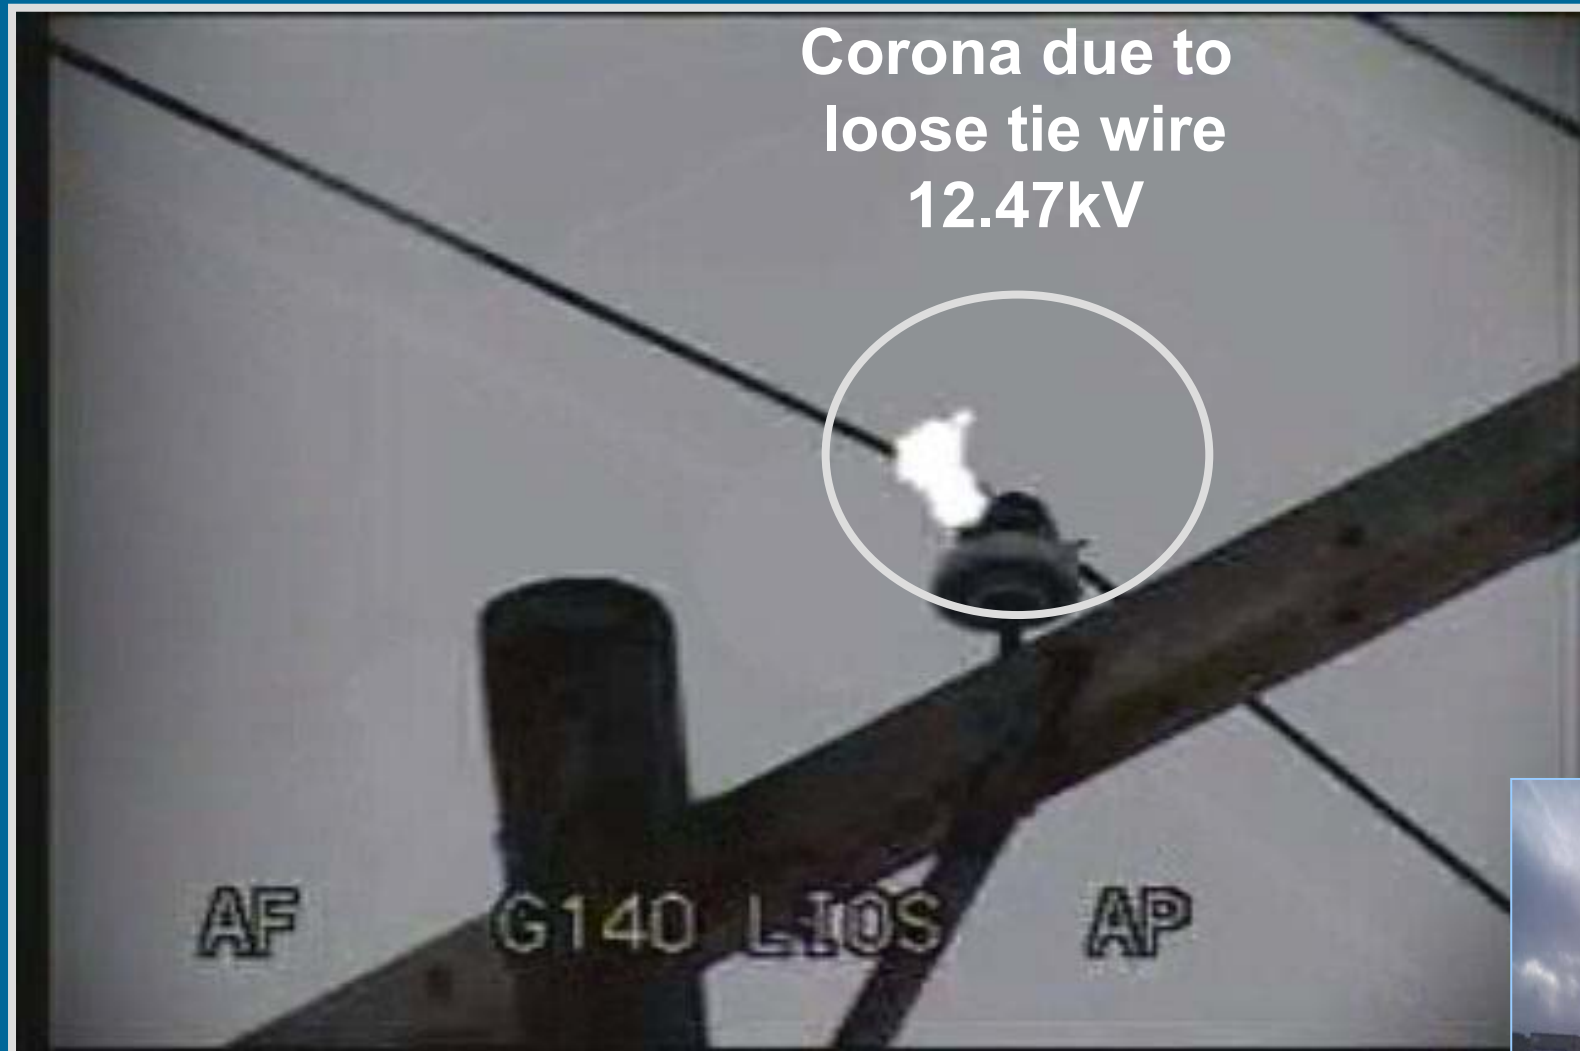
Corona due to a loose tie wire that disturbed radio communication of the control tower of an airport, was immediately located by the DayCor camera.

Line crew replaced **only** the hardware that was found to be defective using the DayCor II Corona Camera.

*“...It took 20 minutes for the line crews to arrive and 30 minutes to replace the defective hardware replacement causing the radio interference, saving time, money and a quick resolution of the radio interference problem...” D.S.*
